UNITED ENGINEERING CONSULTANTS, INC.

FIELD OBSERVATION REPORT PERMIT # BLDC-00620-2022

Report No. 53	Page 1 of 2
Project:	Oceans West One Condominium	Inspection For:	Building Repair and WP Project
Day/Date:	Monday, January 23, 2022	Job No.	20-1153
Location:	1 Oceans West Blvd. DBS, FL 32118	Engineer:	Christopher B. Longman, P.E.
Contractor:	SPEC Contractor Services	Project Foreman:	Alberto
Subcontractor:	None	Inspector:	Christopher Longman P.E./ Andrew Holland
Weather:	62 Degrees @ 9:05 A.M.	Cloudy	Breezy 10% Chance of Rain
Workforce Total:	17		
Activities:	Tower A: Final punchout inspection 01/06 stack, Concrete demo 01/02 stack, Post tension cable repair 7A1, sealant replacement 05/06 stack, Deck coating 04/05 stack, Stressing post tension cable at parking deck

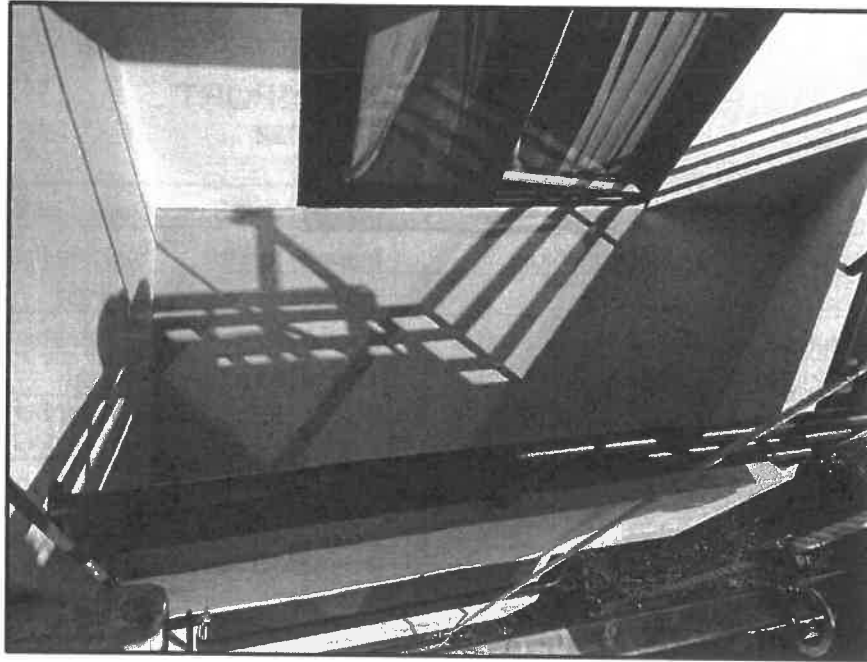
Tower A: The Contractor requested a final punchout inspection for the completed waterproofing, painting and general cleanup at the 01/06 balcony stack (see photos 1 and 2). The paint application was professional in appearance with no holidays observed. Deck coating was evenly applied and continued up the cant bead as specified. The railings and sliding glass doors were construction cleaned and free of debris. The following items were brought to the Foremans attention: 19A1 – Paint blister on top of knee wall, 8A6 – minor blisters on top of deck. The work at the 01/06 balcony stack is accepted and the swing stage is approved to be moved following completion of the items listed above.

Photograph #1: Typical completed scope of work at a balcony on the 01/06 stack

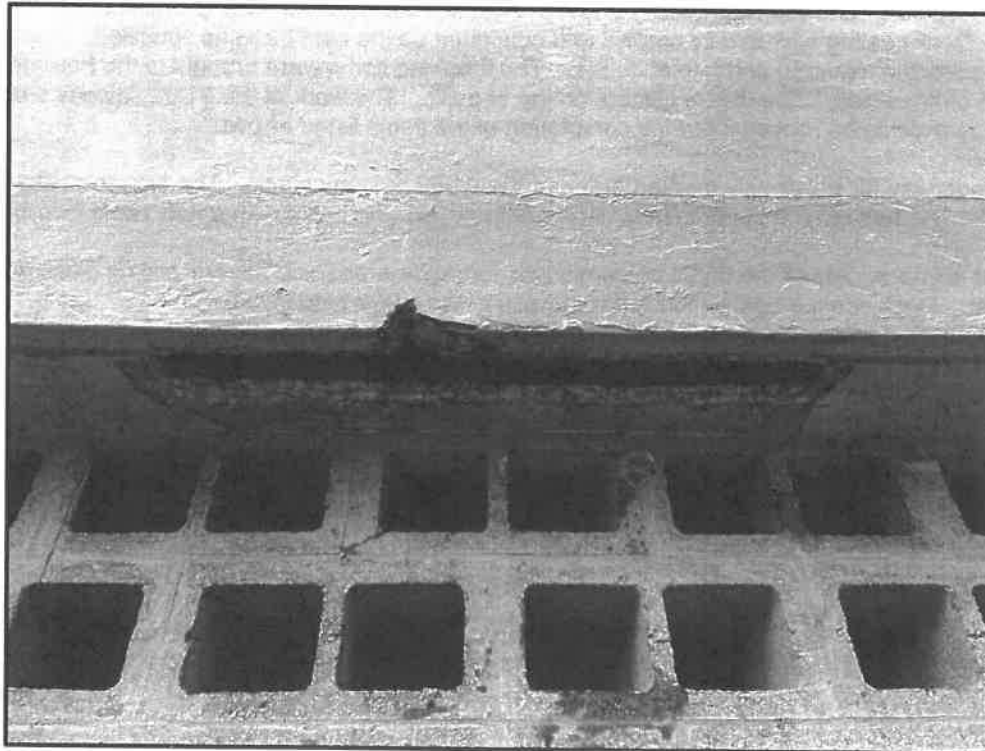
The Contractor has replaced the Northernmost post tension cable within the Northernmost band set at the parking deck (see photos 3 and 4). It was verified that the new cable was protected with new sheathing at each exposed area along the North end of the deck. UEC was on-site to oversee the stressing. It was verified that the calibration documents were up-to-date and coincided with the stressing gauge and ram utilized today. The stressing pressures and cable elongation were recorded. The cable was successfully stressed to 5400 psa gauge pressure which equates to approximately 33 Kips. The cable had an elongation of 15 3/4" with both ends combined which equated to slightly less than the calculated length. The cables will be stressed again next week to verify the pressures and elongation are adequate.

Photograph #2: New sheathing installed on newly installed post tension cable at parking deck
