FIELD OBSERVATION REPORT PERMIT # BLDC-00620-2022

Report No. 78	Page 1 of 2
Project:	Oceans West One Condominium	Inspection For:	Building Repair and WP Project
Day/Date:	Monday, June 26, 2023	Job No.	20-1153
Location:	1 Oceans West Blvd. DBS, FL 32118	Engineer:	Christopher B. Longman, P.E.
Contractor:	SPEC Contractor Services	Project Foreman:	Alberto
Subcontractor:	None	Inspector:	Christopher B. Longman, P.E. Andrew Holland
Weather:	90 Degrees @ 1:25 P.M.	Sunny	Breezy
			20% Chance of Rain
Workforce Total:	9		
Activities:	Concrete repair 03/04 balcony stack (Tower A), Post tension repair pool deck/garage

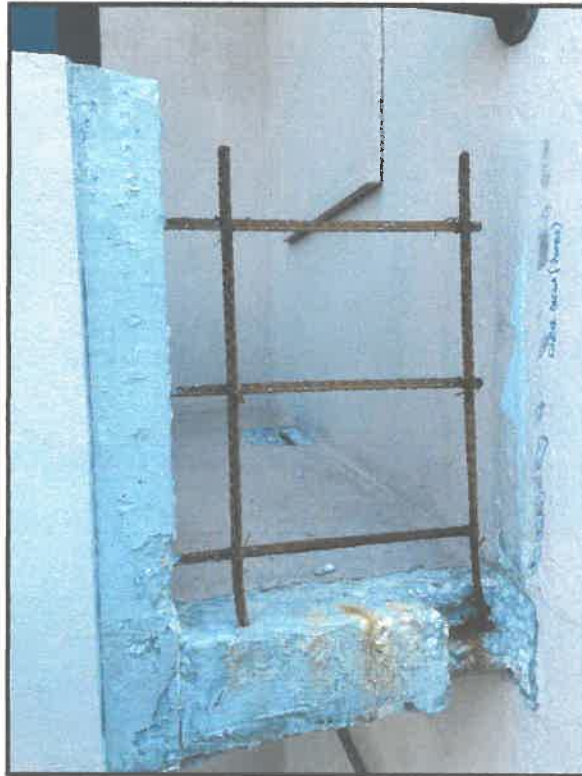
The Contractor requested a final inspection for several completed concrete repairs at the 03/04 balcony stack. UEC inspected and verified that the existing steel was cleaned and free of scale. The excavations continued to sound concrete and conformed to ICRI specifications for excavation geometry, surface profile and circumference around the reinforcing steel. The completed balcony repairs inspected today are approved to be cast. UEC provided direction to supplement the knee wall repairs at the balconies of Units 11A3, 6A4 and 2A4 (see photo 1). The necked down vertical bars were requested to be supplemented by epoxy dowelling in a new vertical hook bar. A final inspection for the remaining repairs at the elevated floors of the 03/04 balcony stack will be completed after the supplemental steel is installed.

Photograph #1: Typical knee wall repair at the 04 balcony stack requiring supplemental steel
