# UNITED ENGINEERING CONSULTANTS, INC.

## FIELD OBSERVATION REPORT PERMIT # BLDC-00620-2022

Report No. 72	Page 1 of 2
Project:	Oceans West One Condominium	Inspection For:	Building Repair and WP Project
Day/Date:	Monday, April 24, 2023	Job No.	20-1153
Location:	1 Oceans West Blvd. DBS, FL 32118	Engineer:	Christopher B. Longman, P.E.
Contractor:	SPEC Contractor Services	Project Foreman:	Alberto
Subcontractor:	None	Inspector:	Christopher B. Longman, P.E.
Weather:	74 Degrees @ 8:55 A.M. Rain	Overcast	Breezy 10% Chance of
Workforce Total:	14		
Activities:	Tower A: Painting 02 window wall, Inspected 06 window wall, Concrete repair 03/04 stack, Painting garage entrance walls, Post tension cable repair pool deck

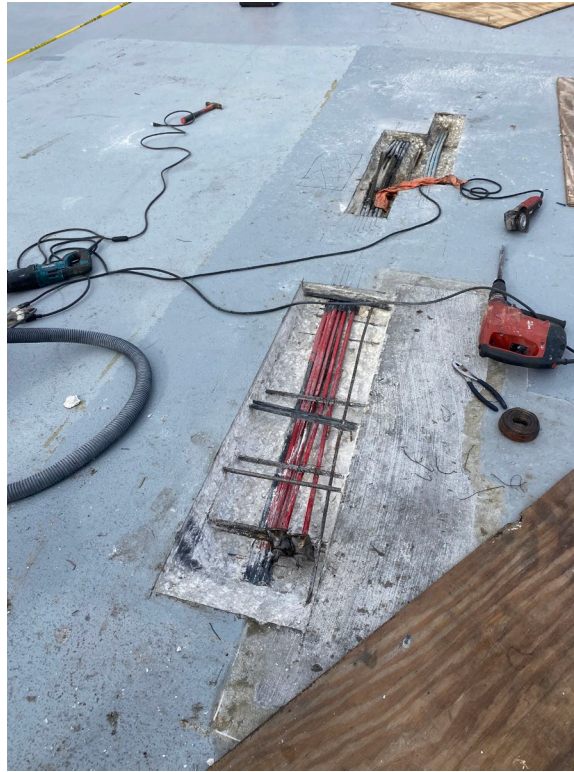
Contractor requested an inspection for several topside slab repair excavations on the pool deck along column line 9A. The excavations were made to access the post tensioned cables. Two new anchors were installed for add cables at the West end. All exposed cable sheathing was repaired and the exposed reinforcing steel was cleaned to remove grease. The repairs were approved to be cast back. The repair material will be MasterEmaco 10-61 EX, an approved mortar.

**Photograph #1: Typical slab repair at the pool deck**
