## FIELD OBSERVATION REPORT

### PERMIT # BLDC-00620-2022

Report No. 17	Page 1 of 2
Project:	Oceans West One Condominium	Inspection For:	Building Repair and WP Project
Day/Date:	Wednesday, August 3, 2022	Job No.	20-1153
Location:	1 Oceans West Blvd. DBS, FL 32118	Engineer:	Christopher B. Longman, P.E.
Contractor:	SPEC Contractor Services	Project Foreman:	Alberto
Subcontractor:	None	Inspector:	Christopher B. Longman, P.E.
Weather:	77 Degrees @ 8:38 A.M.	Sunny	Calm winds 30% Chance of Rain
Workforce Total:	16		
Activities:	Punch-out 01/02, Concrete repair 01/06, paint touch up 05/06

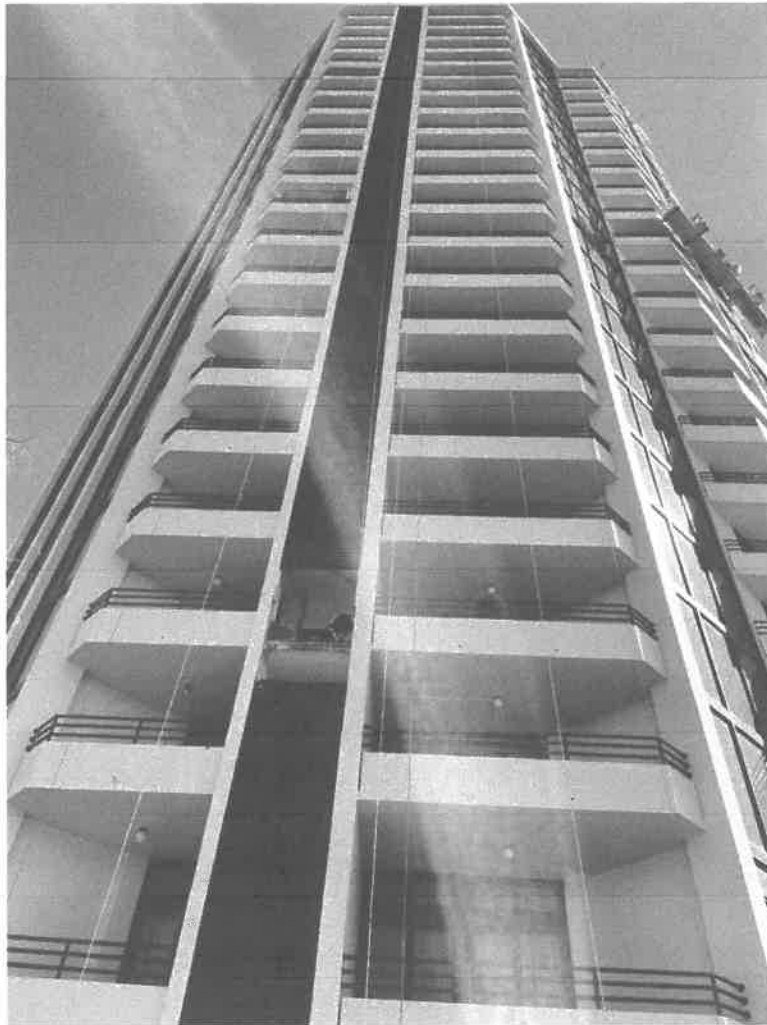
UEC was on-site to verify the items observed on the previous punch-out of the top half of the 01/02 stack were corrected (see photo 1). The items observed were corrected as requested. UEC completed a punchout for the bottom half of the 01/02 stack today as well. The completed paint work appeared professional. The deck coating cut in was neat and continued up the cant bead as specified. Installed sealants were properly tooled and compressed. There was a few small areas that the paint was peeling above the floor line sealant at the bottom 3 floors. The issue was brought to the Contractors attention to be corrected.

Photograph #1: Completed punchout at the 01/02 stack
