UNITED ENGINEERING CONSULTANTS, INC.

FIELD OBSERVATION REPORT PERMIT # BLDC-00620-2022

Report No. 71	Page 1 of 2
Project:	Oceans West One Condominium	Inspection For:	Building Repair and WP Project
Day/Date:	Tuesday, April 18, 2023	Job No.	20-1153
Location:	1 Oceans West Blvd. DBS, FL 32118	Engineer:	Christopher B. Longman, P.E.
Contractor:	SPEC Contractor Services	Project Foreman:	Alberto
Subcontractor:	None	Inspector:	Andrew Holland Christopher B. Longman, P.E.
Weather:	72 Degrees @ 11:40 A.M.	Sunny	Breezy 0% Chance of Rain
Workforce Total:	16		
Activities:	Tower A: Identified damage 02 window wall, Inspected concrete repair 03/04 stack, Painting garage entrance walls, Locating post tension cables pool deck

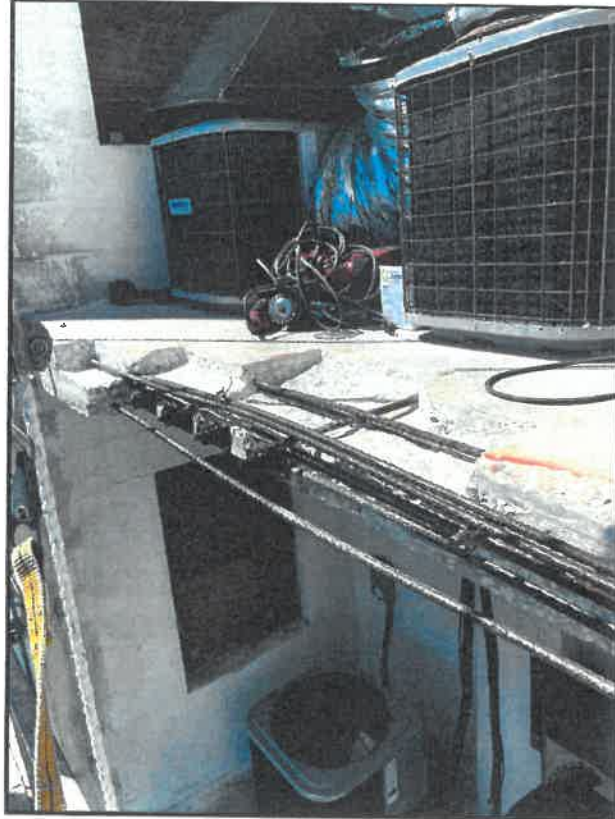
Concrete excavations in the A/C closet of the 03/04 balcony stack have been completed (see photos 1 and 2). The demo at the slab edge was able to be completed in front of the post tension anchors and no lock offs were required. UEC inspected the completed excavations to verify conformance with ICRI specifications. Direction was provided to supplement several necked down bars by epoxy dowelling in new steel and lap splicing. Two of the repairs were requested to be further excavated to chase the corroded steel. A final inspection will be completed after the supplemental steel is installed and the two repairs are further excavated.

Photograph #1: Typical slab edge excavation at the 03/04 balcony stack

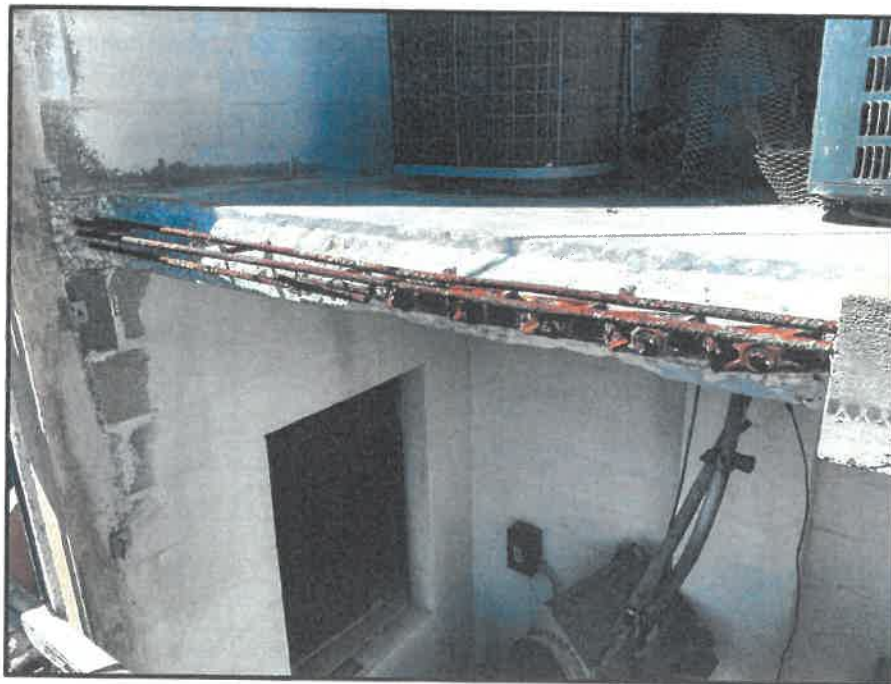
Photograph #2: Typical slab edge excavation at the 03/04 balcony stack
