UNITED ENGINEERING CONSULTANTS, INC.

FIELD OBSERVATION REPORT PERMIT # BLDC-00620-2022

Report No. 34	Page 1 of 2
Project:	Oceans West One Condominium	Inspection For:	Building Repair and WP Project
Day/Date:	Thursday, October 20, 2022	Job No.	20-1153
Location:	1 Oceans West Blvd. DBS, FL 32118	Engineer:	Christopher B. Longman, P.E.
Contractor:	SPEC Contractor Services	Project Foreman:	Alberto
Subcontractor:	None	Inspector:	Christopher B. Longman, P.E.
Weather:	72 Degrees @ 2:50 P.M.	Mostly Sunny	Breezy Winds 0% Chance of Rain
Workforce Total:	16		
Activities:	Final inspections for completed repairs, prepping for deck coating

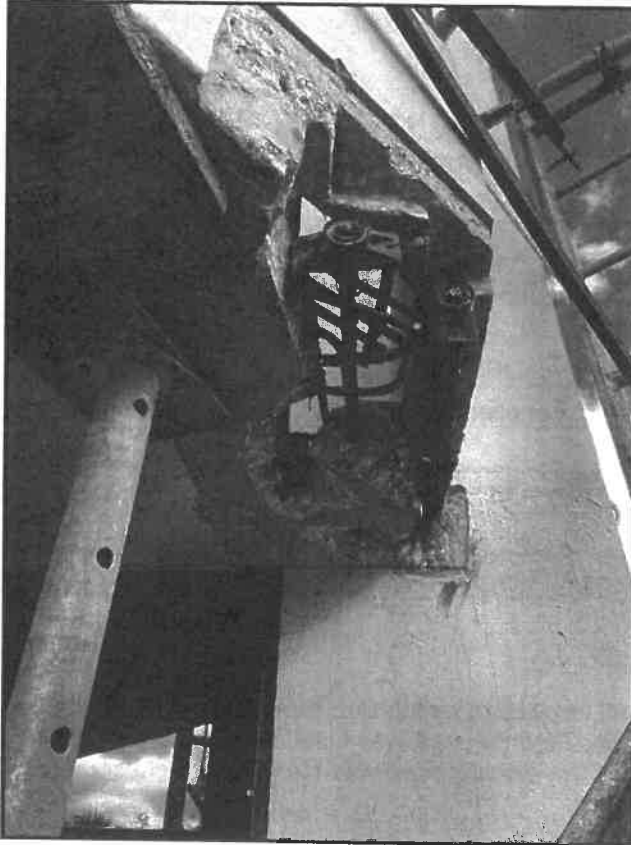
UEC was on site to complete a final inspection for the slab repair, part of the post tension repair, at the balcony of Unit 2B5 (see photos 1 and 2). The supplemental steel was installed by epoxy dowelling as directed. Fractured concrete was excavated to sound concrete. The existing steel was cleaned and chased until no corrosion was observed. The repair is approved to be cast.

Photograph #1: In-progress post tension concrete repair at the balcony of Unit 2B5

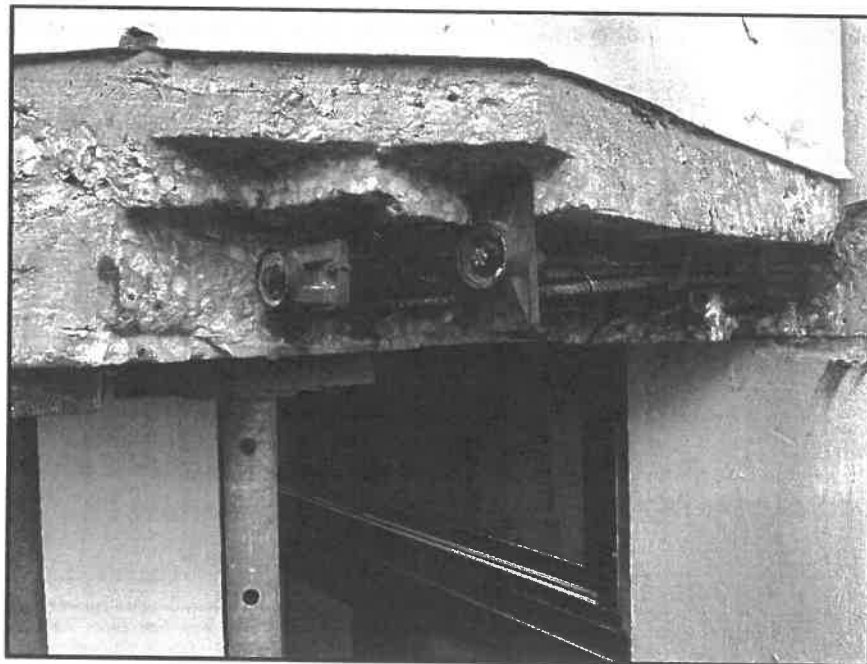
Photograph #2: In-progress post tension concrete repair at the balcony of Unit 2B5
