UNITED ENGINEERING CONSULTANTS, INC.

FIELD OBSERVATION REPORT PERMIT # BLDC-00620-2022

Report No. 56	Page 1 of 2
Project:	Oceans West One Condominium	Inspection For:	Building Repair and WP Project
Day/Date:	Tuesday, January 31, 2023	Job No.	20-1153
Location:	1 Oceans West Blvd. DBS, FL 32118	Engineer:	Christopher B. Longman, P.E.
Contractor:	SPEC Contractor Services	Project Foreman:	Alberto
Subcontractor:	None	Inspector:	Andrew Holland
Weather:	77 Degrees @ 1:55 P.M.	Partly Cloudy	Light Breeze 0% Chance of Rain
Workforce Total:	17		
Activities:	Tower A: Stressing post tension cables at North end of garage and 7A6 balcony, Locating post tension cables in garage, Pressure washing 05/06 stack, Concrete demo 01/02 and 02/03 stacks, Paint touch-up 04/05 stack

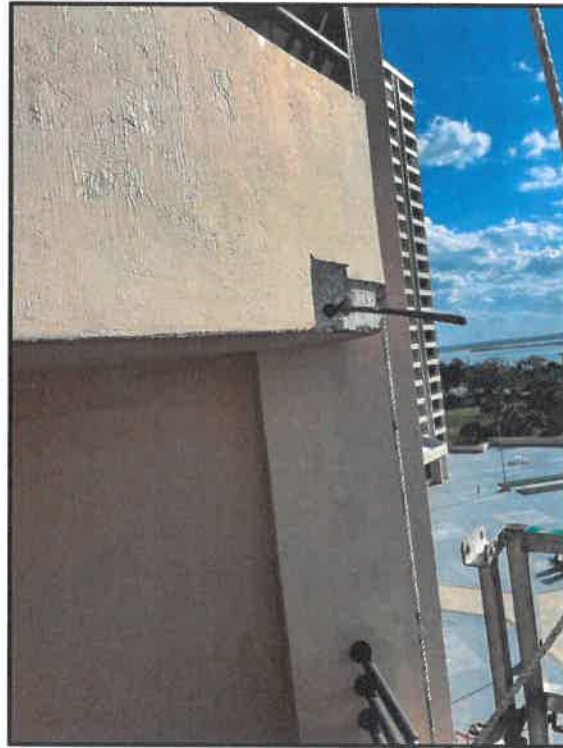
Tower A: UEC was on-site to oversee the stressing of the newly installed post tension cables located at the balcony of Unit 7A6 (05/06stack) and a lift-off at the North end of the parking garage slab (see photo 1). It was verified that the calibration documents were up to date and coincided with the guage and ram utilized today. The stressing pressures and cable elongation were recorded for each cable. The newly installed post tension cable located at the balcony corner of Unit 7A6 was successfully stressed to 5400 psi guage pressure which equates to approximately 33 Kips. The cable had an elongation of 5 1/8" which is within the calculated elongation for the length of cable installed. The Northernmost post tension cable within the Northernmost band set at the parking deck had a lift off performed. The cable was stressed to 5400 psi guage pressure which equates to approximately 33 Kips. The cable had an elongation of 15 7/8" which was 1/8" more than the results from last week.

Photograph #1: Stressing end of post tension cable at the balcony of Unit 7A6

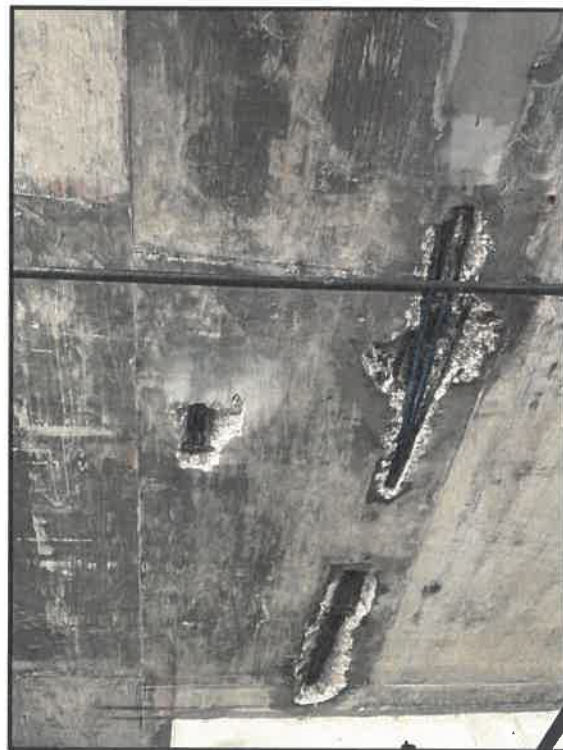
Locating and removing broken post tension cables located in the garage at the banded sets near the electrical room remains in-progress (see photo 2).

Photograph #2: Broken and de-tensioned post tension cables located in the garage
