FIELD OBSERVATION REPORT

Report No. 26	Page 1 of 2
Project:	Oceans West One Condominium	Inspection For:	Building Repair and WP Project
Day/Date:	Monday, August 29, 2022	Job No.	20-1153
Location:	1 Oceans West Blvd. DBS, FL 32118	Engineer:	Christopher B. Longman, P.E.
Contractor:	SPEC Contractor Services	Project Foreman:	Alberto
Subcontractor:	None	Inspector:	Christopher B. Longman, P.E./ Andrew Holland
Weather:	82 Degrees @ 8:30 A.M.	Overcast	Light Breeze 50% Chance of Rain
Workforce Total:	14		
Activities:	Punch-out 05 stack window drop, Identify damage 02/03 balcony stack

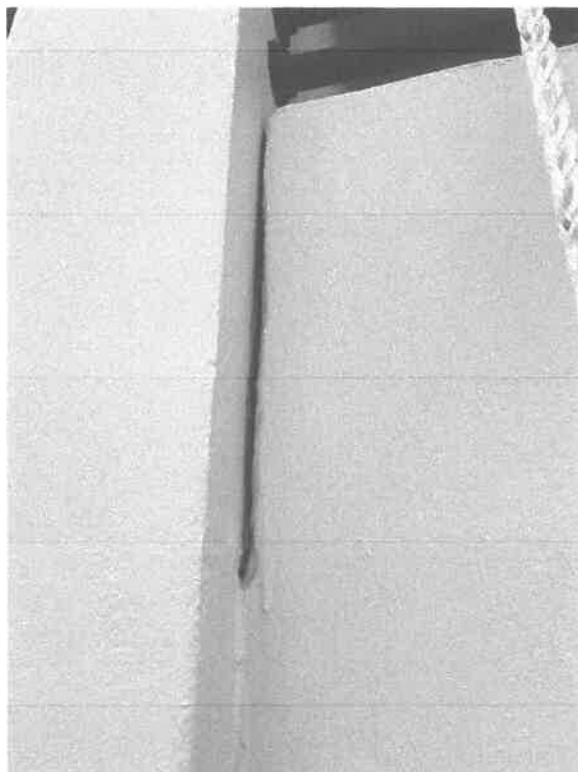
UEC visited each balcony on the 02/03 unit stack to identify stucco and concrete damage (see photo 1 and 2). The slabs, walls and columns were acoustically sounded and visually inspected. Damaged areas were marked with orange paint for excavation. There was nearly no slab damage. A small amount of spalling was identified on the walls and columns. The drain slot between the knee wall and building wall was requested to be opened to improve draining at many balconies.

Photograph #1: Typical balcony knee wall designated to open drain pathway
