UNITED ENGINEERING CONSULTANTS, INC.

FIELD OBSERVATION REPORT PERMIT # BLDC-00620-2022

Report No. 83	Page 1 of 2
Project:	Oceans West One Condominium	Inspection For:	Building Repair and WP Project
Day/Date:	Wednesday, August 16, 2023	Job No.	20-1153
Location:	1 Oceans West Blvd. DBS, FL 32118	Engineer:	Christopher B. Longman, P.E.
Contractor:	SPEC Contractor Services	Project Foreman:	Alberto
Subcontractor:	None	Inspector:	Andrew Holland
Weather:	85 Degrees @ 9:55 A.M.	Sunny	Light Breeze 0% Chance of Rain
Workforce Total:	5		
Activities:	Post tensioned cable stressing pool deck slab

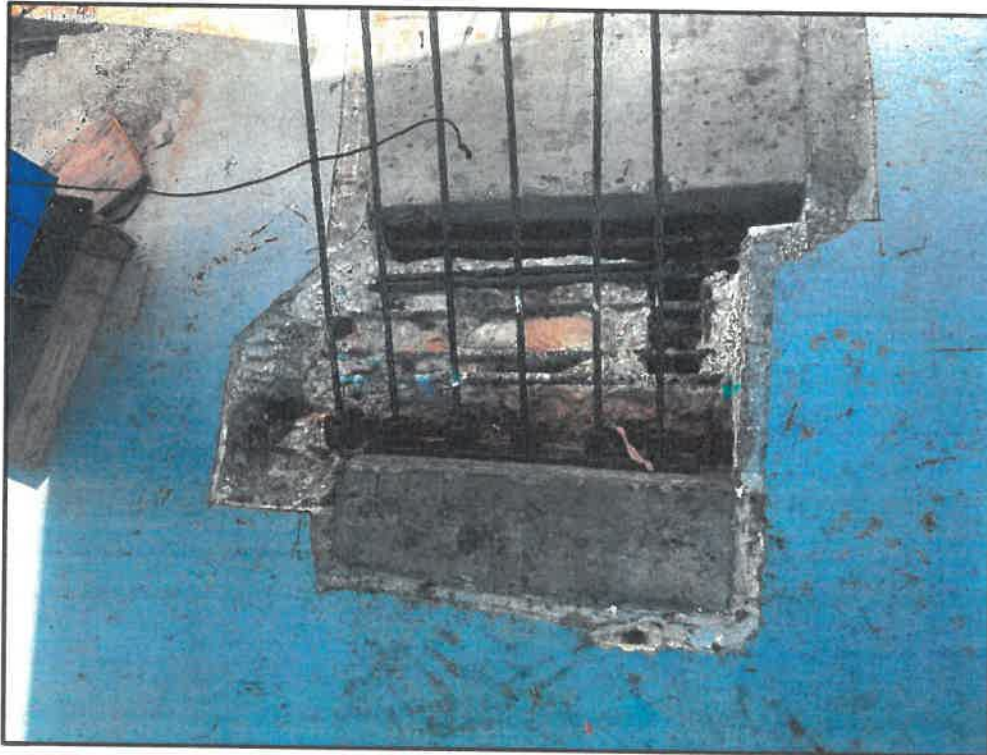
The Contractor has replaced cables 10-13 within the banded set at column line 9A on the pool deck and replaced add cables #6 and 7. The cables were stressed at the anchor points at the West end slab edge and the tube-ups on the West end of the pool deck (see photos 1 and 2). The banded set cables 10-13 has new cable installed and were attached to the existing cable with a coupler at the very East end of the run. The add cables were replaced in full.

Photograph #1: Cables 7,11, 12 and 13 stressed at tube ups

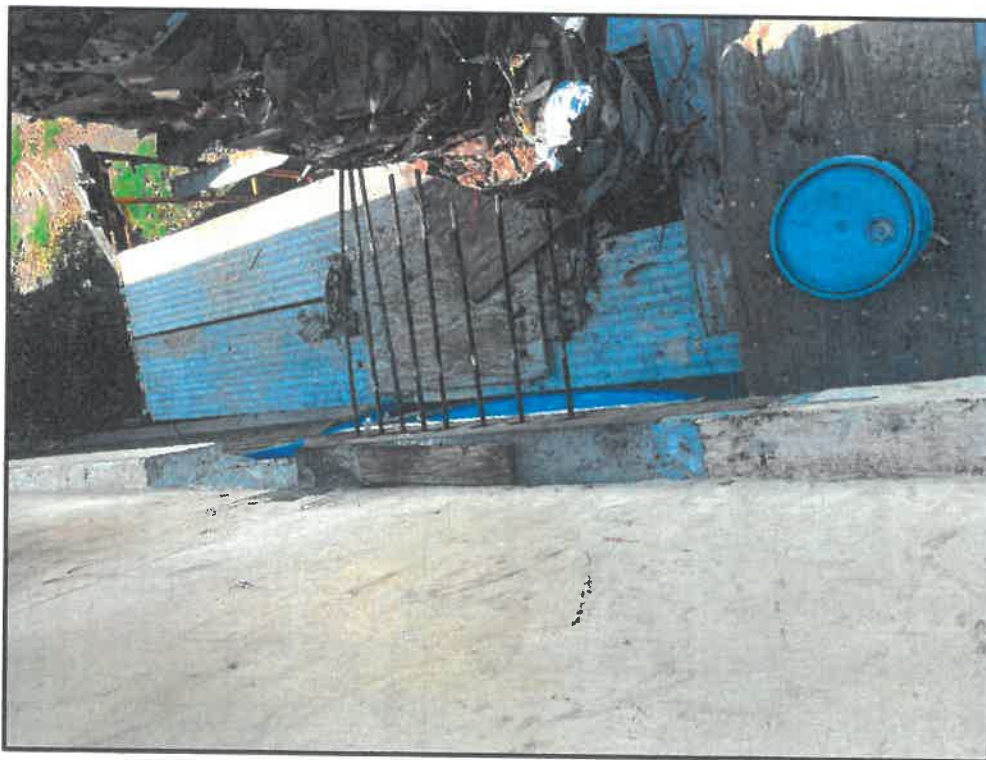
Photograph #2: Add cable 6 and banded cable 10 stressed at West end slab edge
