UNITED ENGINEERING CONSULTANTS, INC.

FIELD OBSERVATION REPORT

PERMIT # BLDC-00620-2022

Report No. 62	Page 1 of 3
Project:	Oceans West One Condominium	Inspection For:	Building Repair and WP Project
Day/Date:	Wednesday, March 8, 2023	Job No.	20-1153
Location:	1 Oceans West Blvd. DBS, FL 32118	Engineer:	Christopher B. Longman, P.E.
Contractor:	SPEC Contractor Services	Project Foreman:	Alberto
Subcontractor:	None	Inspector:	Christopher B. Longman, P.E.
Weather:	75 Degrees @ 9:25 A.M.	Sunny	Windy 0% Chance of Rain
Workforce Total:	16		
Activities:	Tower A: Identified damage 03/04 stack, Painting 01/02 stack and pressure washing 02/03 stack, Inspected repairs on pool deck, Post tension repairs at the pool deck

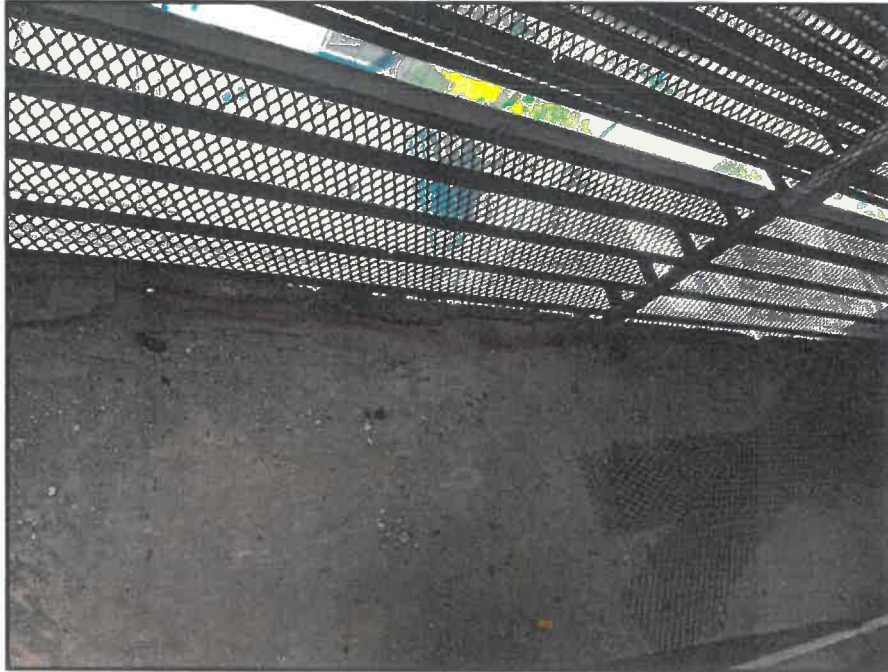
UEC was on-site to inspect and identify concrete and stucco damage at the 03/04 unit balcony stack. The walls, slabs and columns were acoustically sounded and visually inspected on the balconies and at the interior of the A/C closets from the 10th floor down to the 1st floor. Damaged areas were marked with orange paint and were identified at almost every slab edge in the A/C closets. Minimal concrete damage was detected on the balconies; however, significant damage was identified on the slabs inside of the A/C closets. Many of the louvers will need to be removed to access the slab edge for repair.

Photograph #1: Damage identified at the 10th floor slab edge in the A/C closet of the 03/04 stack

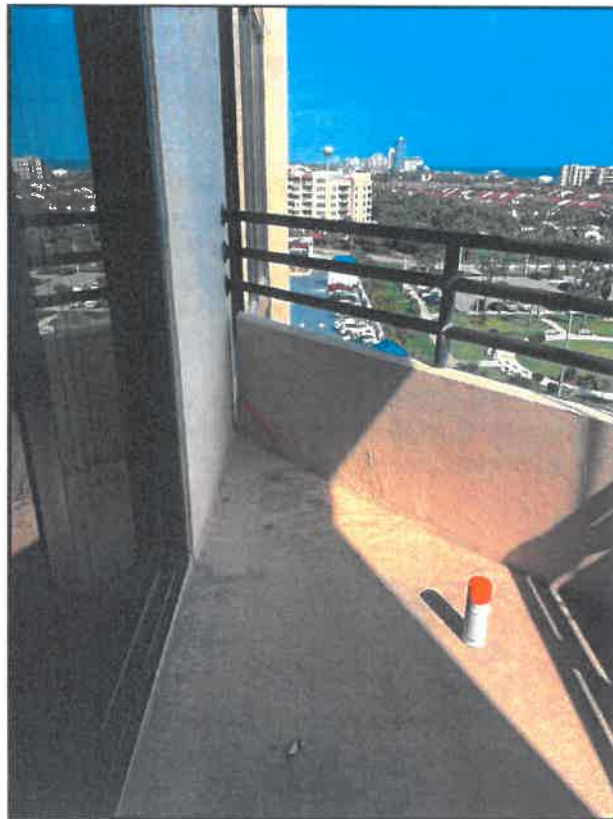
Photograph #2: Damage identified at the balcony of Unit 9A3

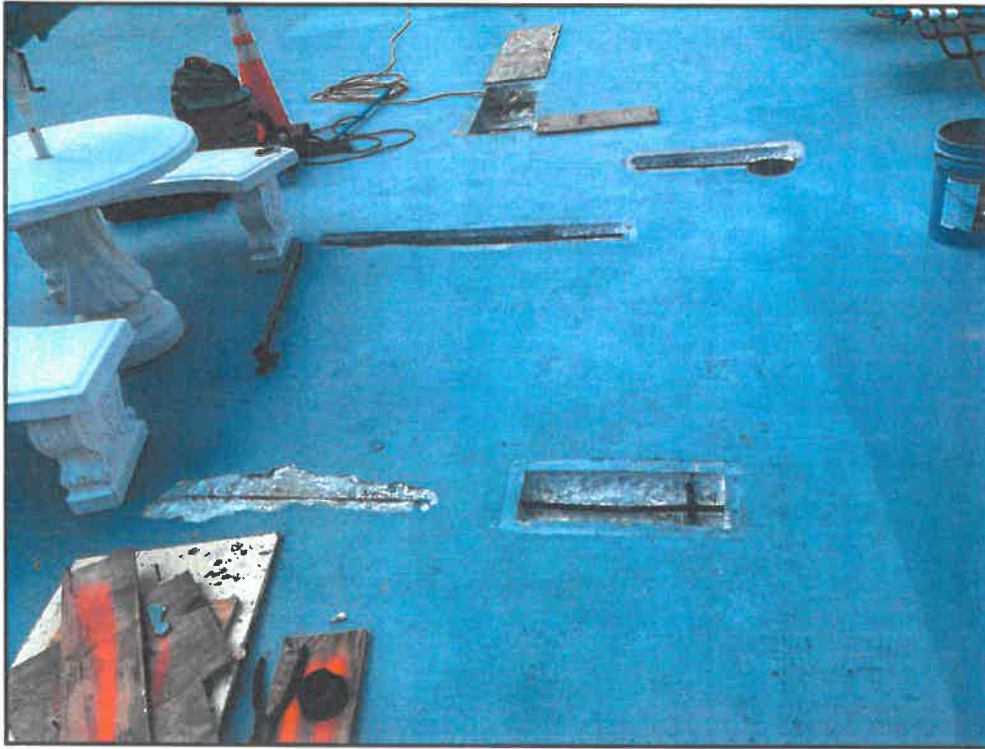
UEC completed an inspection for several completed topside concrete repairs located on the pool deck. It was verified that the repairs conformed to ICRI standards for excavation geometry, surface profile and circumference around the reinforcing steel. MCI corrosion inhibitor was applied to the repair area and will be washed off prior to casting. The existing steel was cleaned and the repairs are approved to be cast.

Photograph #3: Accepted and in-progress concrete repairs at the topside of the pool deck

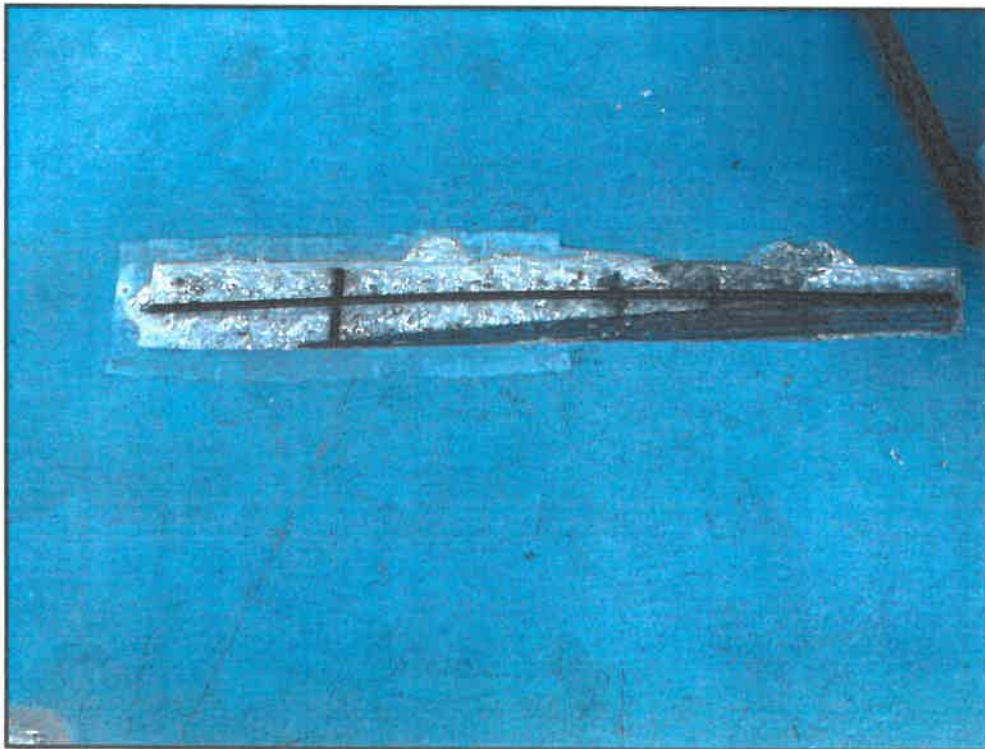
Photograph #4: Accepted concrete repair located on the topside of the pool deck
