FIELD OBSERVATION REPORT PERMIT # BLDC-00620-2022

| | | Report No. 35 | Page 1 of 2 |
| Project: | Oceans West One Condominium | Inspection For: | Building Repair and WP Project |
| Day/Date: | Monday, October 24, 2022 | Job No. | 20-1153 |

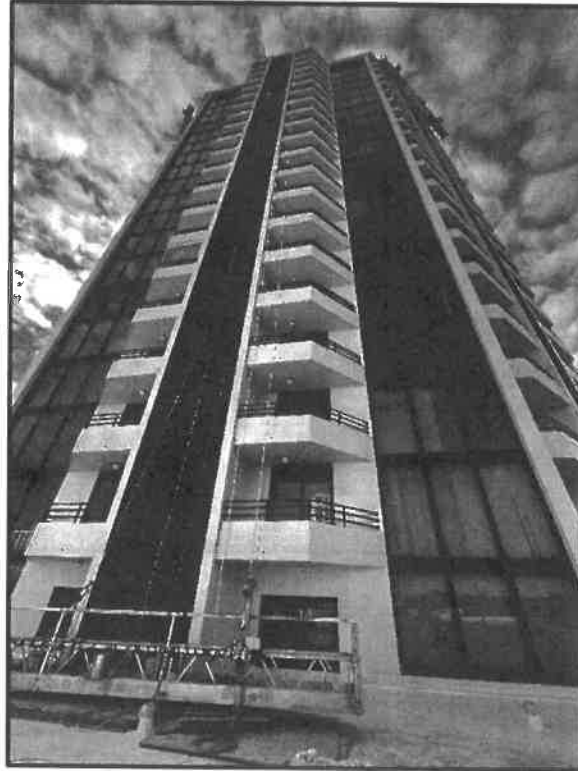
The Contractor requested a final punchout inspection for the completed painting, waterproofing and general cleanup at the 04/03 balcony stack (see photos 1 and 2). The paint application appeared professional with a neat cut in and no holidays observed. Deck coatings were evenly applied and continued up the cant bead as specified. The doors and railings were construction cleaned and appeared to be free of paint droplets. The following items were brought to the Contractors attention to be corrected: 12B4, 11B3, and 9B3 – excess paint on light fixture, 8B4 – small spall on knee wall, 8B4, 3B4 and 3B3 – clean debris from corner knee wall drains near AC closet. It was also requested for the Foreman to check the corner knee wall drains at each elevation for debris or coating buildup so that the balcony would have proper drainage. The stages are approved to be moved after the items listed above are completed.

Photograph #1: Completed painting and cleanup at the 04/03 balcony stack

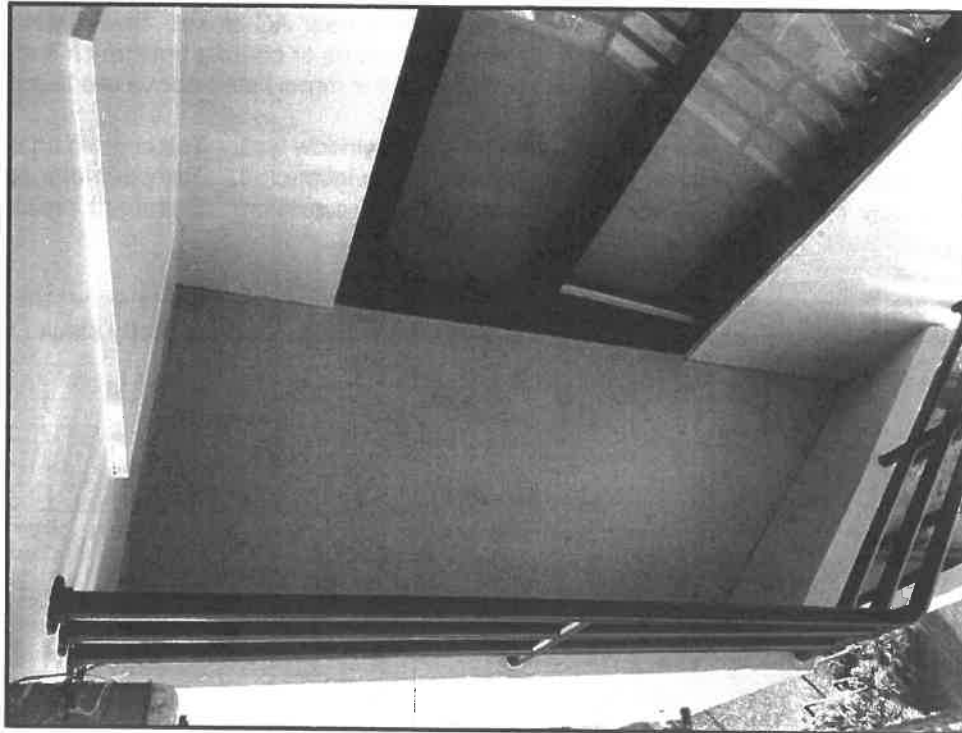
Photograph #2: Typical completed painting and cleanup at a balcony on the 03 stack
